# VALLES CALDERA NATIONAL PRESERVE

## Environmental Assessment

*San Antonio Watershed -  
Wetlands & Riparian Restoration*

## San Antonio Watershed – Wetlands & Riparian Restoration

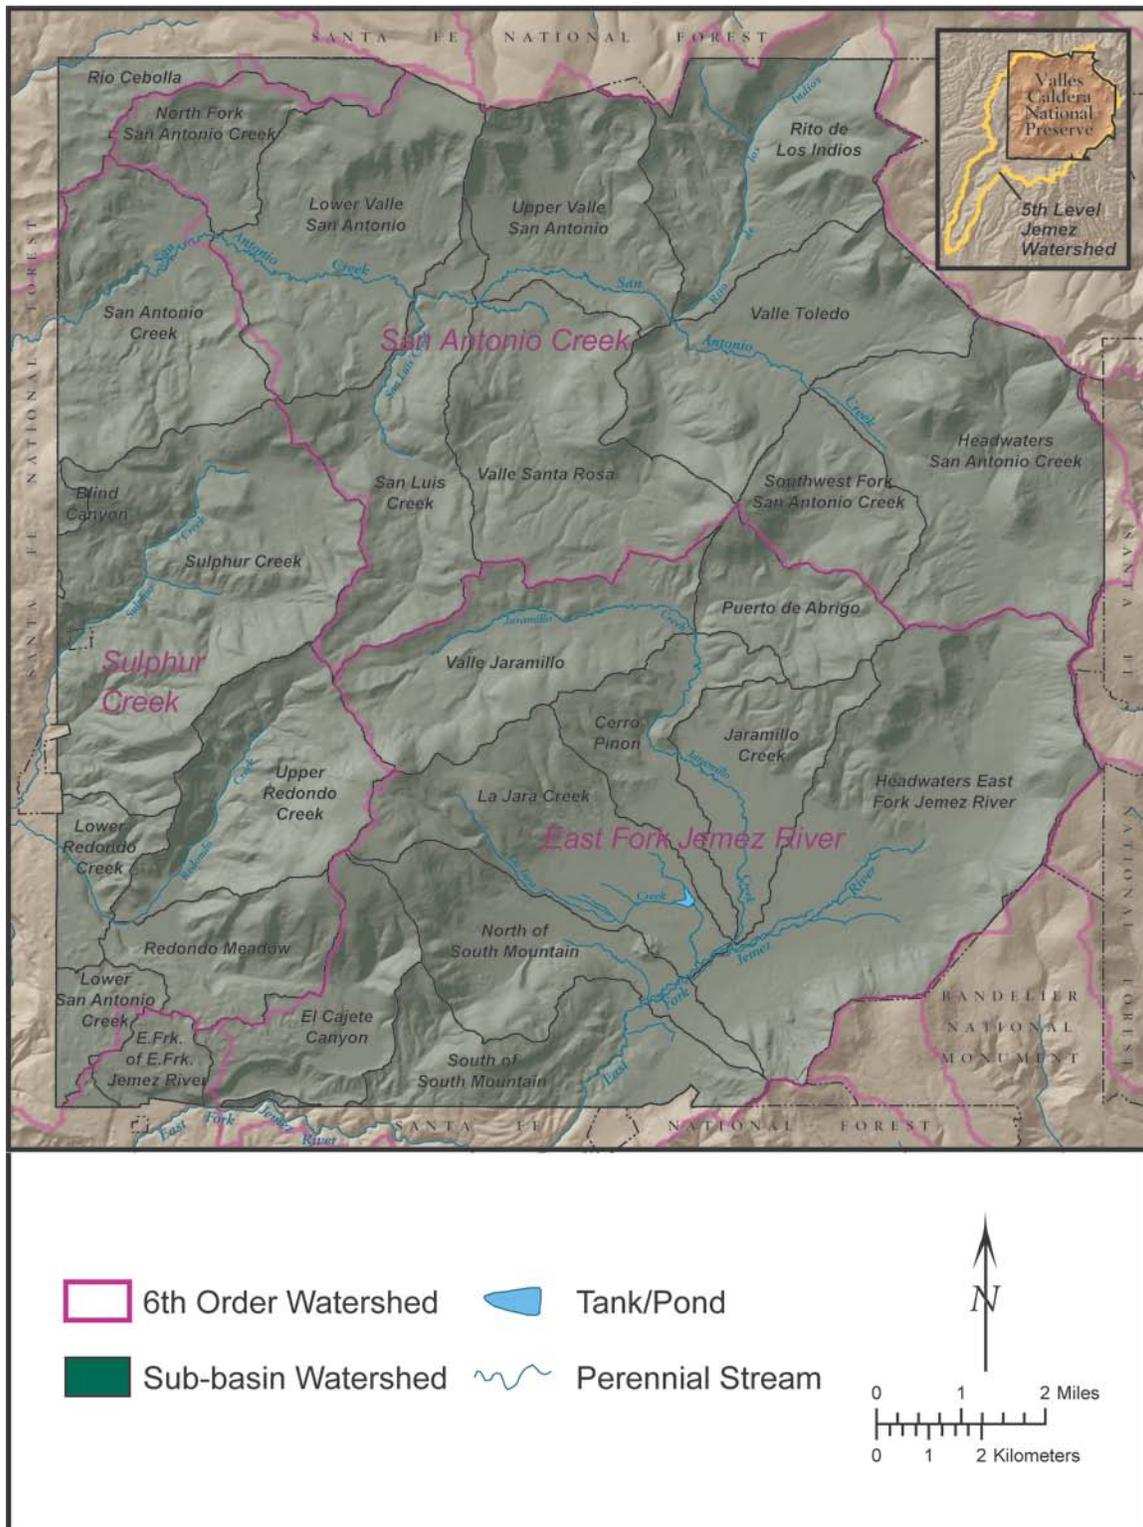
Figure 2 – Watershed Delineations

*Watershed* is the term used to define a geographic area of land from which water drains to a shared destination. Watersheds can be defined at a variety of scales. For the purpose of this EA, three scales will be defined (**Error! Reference source not found.**):

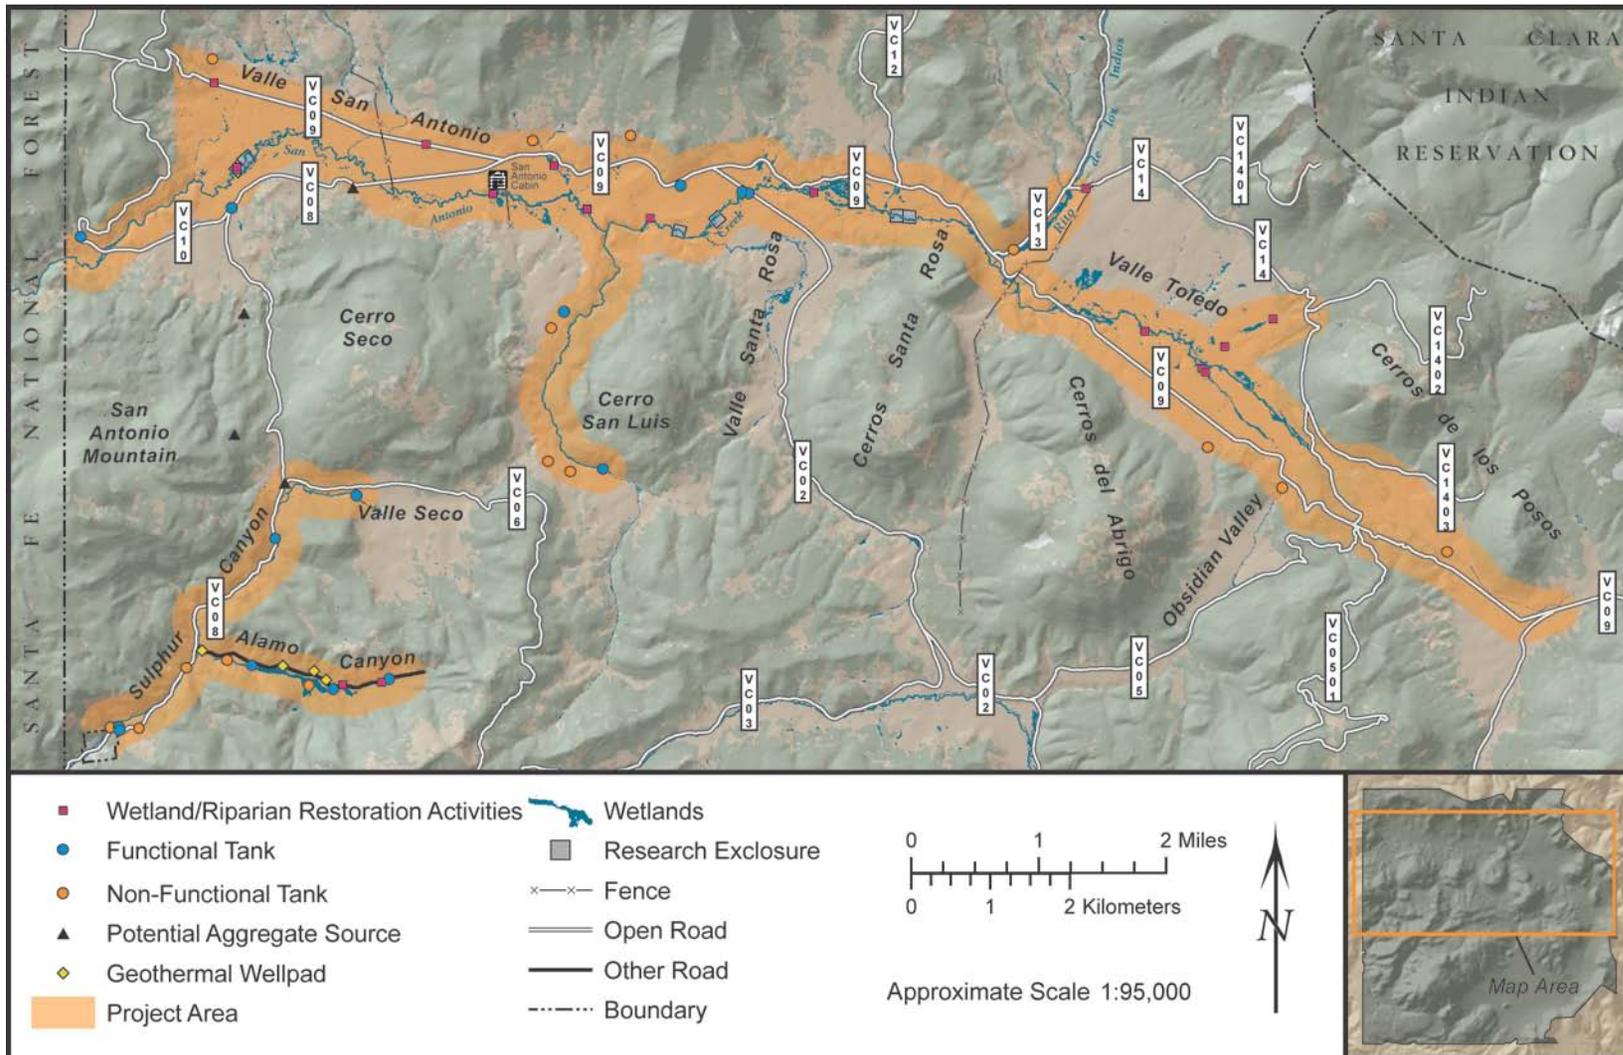
Figure 3 – Project Area and Proposed Activities

- #1 **Improve drainage along VC09, VC13, VC09, VC09A** – Installation of rolling dips along VC09A to move water off the road system where it can be harvested into a stable wet meadow system. Use of this road would continue to be limited to administrative uses, preferably under dry conditions only. Deferred maintenance activities on VC09, VC09A and VC13 would include:

- Culvert replacement and installation of relief culverts.
  - Reshaping and crowning of the road prism to provide proper drainage to reduce erosion.
  - Road realignment to reduce slope and erosion.

- Construction of low water crossings
  - Intersections will be reworked to provide proper drainage and reduce erosion.
- #2 **Relocate/remove Fencing** - Livestock fencing that is perpendicular to San Antonio Creek or otherwise located to cause trailing and erosion, would be relocated, removed, or replaced with temporary fencing depending on administrative needs.

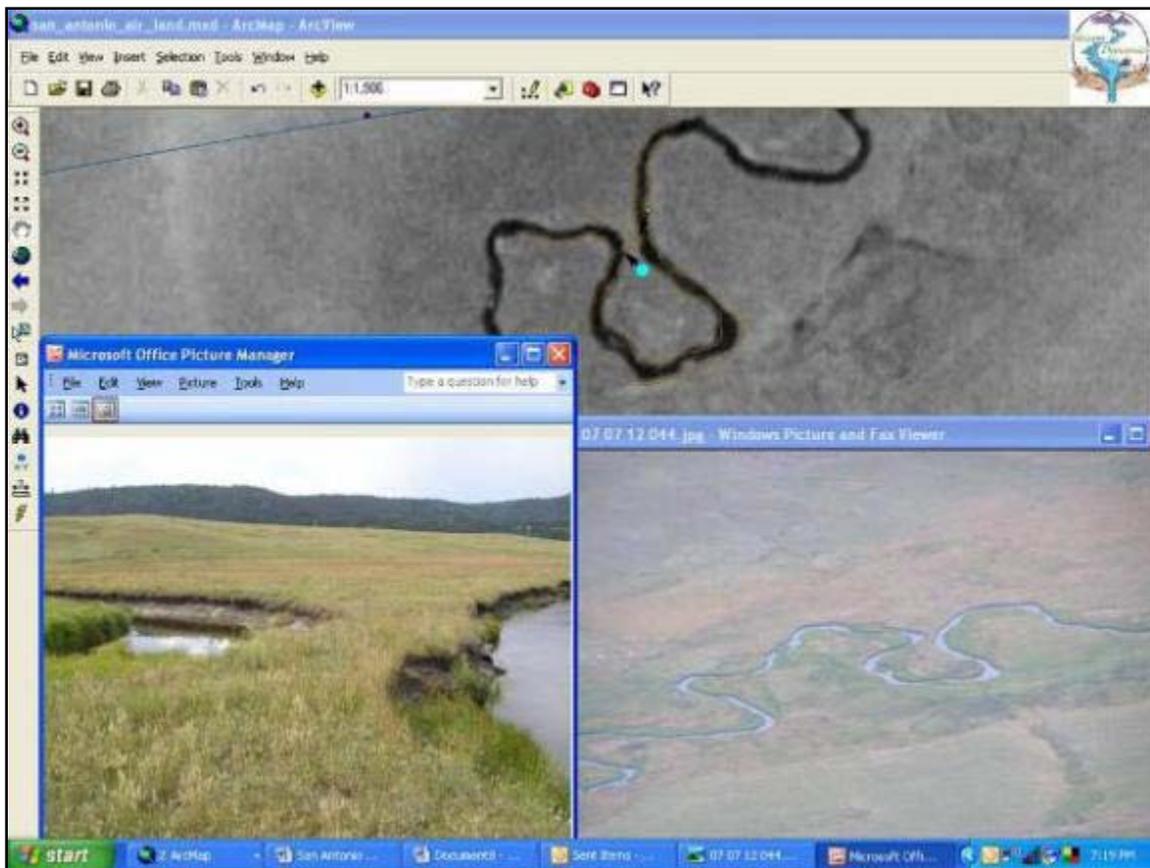
Figure 10 – An incipient meander cutoff shown from various perspectives (Van Clothier; Stream Dynamics Inc. 2008)

The issues and trends identified in the purpose and need for action would continue. Among these issues is the addressing of “incipient meander cut-offs” (see Figure 10). These cut-offs may cause a headcut to go up channel. Incipient meander cut-offs are accelerated from inappropriate livestock grazing practices, logging, and roads which increase sediment yield to streams. The stream has incised into its banks and wetland acreage has decreased. It is natural for streams to deposit excess sediment supply on the inside of a meander. However, the stream would not be changing shape at such a rapid rate unless disturbed. If several meander cut-offs occur at the same time, the channel will steepen, degrade upstream, and change in gradient. This could cause a loss of wetlands (Van Clothier; Stream Dynamics Inc. 2008).
